CASE STUDY

REDESIGNING STOPES FOR IMPROVED RECOVERY OF ORE

PROJECT SUMMARY

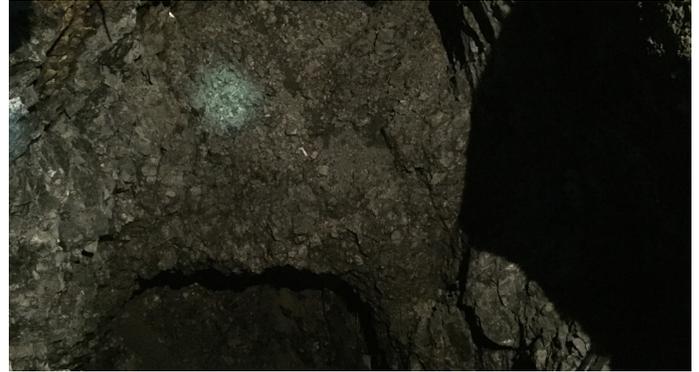
Although the customer had initially assumed the issues they were experiencing could be resolved with different delay times, the investigation on site quickly revealed that the issue was related to lack of relief for the stope blasts.

The void into which the rock from the stopes was designed to expand was far too little to allow for proper rock breakage. DynoConsult's representative informed the mining engineers at that time that most, if not all, of their blasting issues could be resolved by redesigning their stope panels to incorporate a greater void for relief.

After the investigation, the DynoConsult representative sat down with the mining engineers and worked out a new stope development plan that would produce the proper amount of void in the panel for proper rock expansion.
